**Flood Control Project Maintenance
Levee Inspections**

Fall 2015 Levee Maintenance Deficiency Summary Report

San Joaquin River Basin

Reclamation District No. 0017 Mossdale

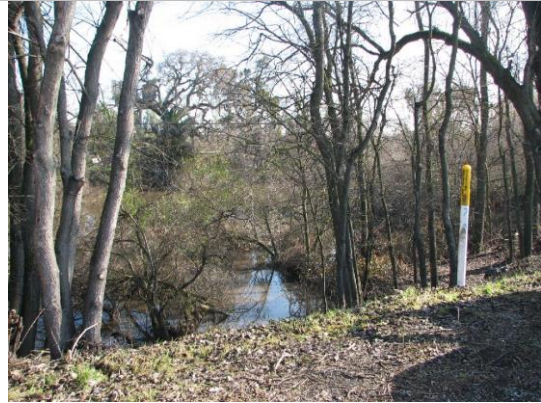
Photo 3 of 3 : UCIP_FA_2015_0700.jpg

LM Start	0.03	Rating **	M	Issue No.	7 (cont)
LM End	0.03	Issue Type +	En	Location *	N/A
Category	Supplemental			GPS Latitude/Longitude	
				Start	End
Item	DWR UCIP Field Study			37.911561 °	37.911561 °
				-121.291441 °	-121.291441 °
DWR ID					
Action/Comments					
Inspector Comments: FS_ID:40603 DS_ID:1 EP_NO: 6623 FS_HLM: 0.02 Repair Type: Non-Urgent Crossing Status: Found

View of waterward side.

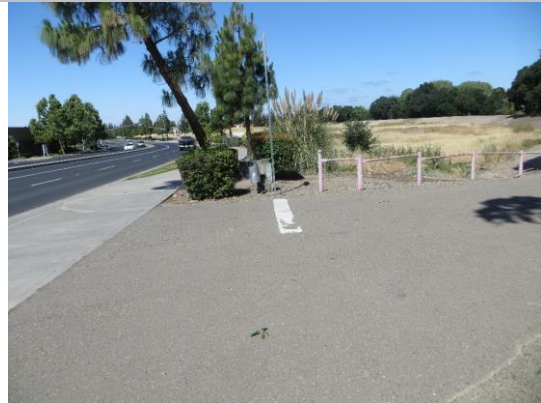
Photo 1 of 3 : UCIP_FA_2015_6721.jpg

LM Start	0.15	Rating **	U	Issue No.	8
LM End	0.15	Issue Type +	En	Location *	N/A
Category	Supplemental			GPS Latitude/Longitude	
				Start	End
Item	DWR UCIP Field Study			37.912850 °	37.912850 °
				-121.292910 °	-121.292910 °
DWR ID					
Action/Comments					
Inspector Comments: FS_ID:46010 DS_ID:72 EP_NO: 15185 FS_HLM: 0.15 Repair Type: Urgent Crossing Status: Indicator Found UCIP Comments: Need to install gasoline markers. FIELD_STRUCT_DESC: 8-inch-diameter soil proofed steel gas main through the left bank levee and under the channel of French Camp Slough. The pipeline has a minimum cover of 5 feet within the overflow areas and under the channel. (Permit No. 15185-1989) FS Date: 05/19/2015

LS crown. No gasoline markers.

Inspector Comments: FS_ID:46010
 DS_ID:72
 EP_NO: 15185
 FS_HLM: 0.15
 Repair Type: Urgent
 Crossing Status: Indicator Found
 UCIP Comments: Need to install gasoline markers.
 FIELD_STRUCT_DESC: 8-inch-diameter soil proofed steel gas main through the left bank levee and under the channel of French Camp Slough. The pipeline has a minimum cover of 5 feet within the overflow areas and under the channel. (Permit No. 15185-1989)
 FS Date: 05/19/2015

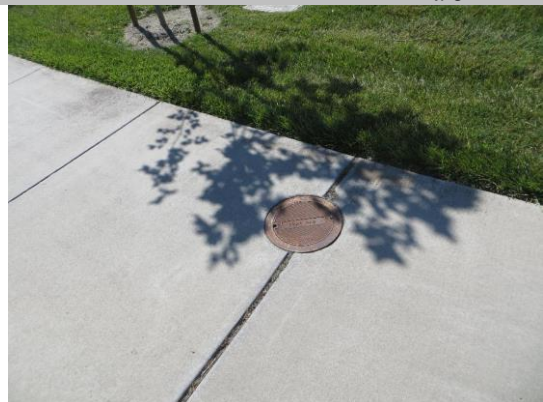
Photo 3 of 3 : UCIP_FA_2015_6723.jpg

Gas access lid in sidewalk Approximately 200-feet to west of crown.

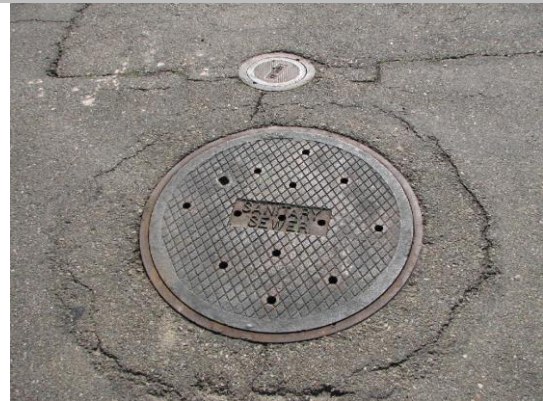
Photo 1 of 3 : UCIP_FA_2015_2333.jpg

LM Start	1.31	Rating **	M	Issue No.	9
LM End	1.31	Issue Type +	En	Location *	WS
Category	Supplemental			GPS Latitude/Longitude	
				Start	End
Item	DWR UCIP Field Study			37.915928 °	37.915928 °
				-121.312471 °	-121.312471 °
DWR ID					
Action/Comments					
Inspector Comments: FS_ID:40606 DS_ID:158 EP_NO: 14992 FS_HLM: 1.33 Repair Type: Non-Urgent Crossing Status: Indicator Found UCIP Comments: Need to contact owner to determine status of crossing. Also need date of last inspection. FIELD_STRUCT_DESC: 3 of 3. A 12-inch diameter HDPE sewer force main (SFM). All pipes encased in concrete at approximately 32 feet below levee crown. (Permit No. 14992-1989) FS Date: 02/03/2010

Manhole visible on landward side.

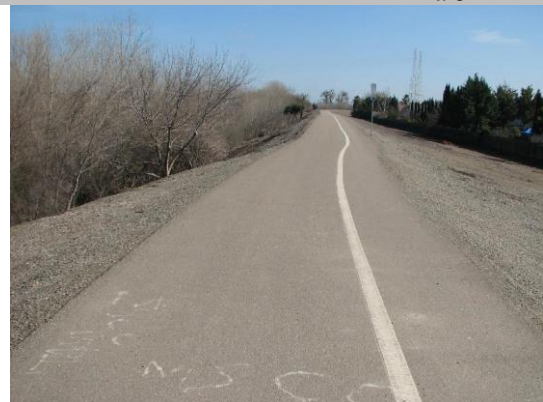
Photo 3 of 3 : UCIP_FA_2015_2338.jpg

View of levee crown at crossing.

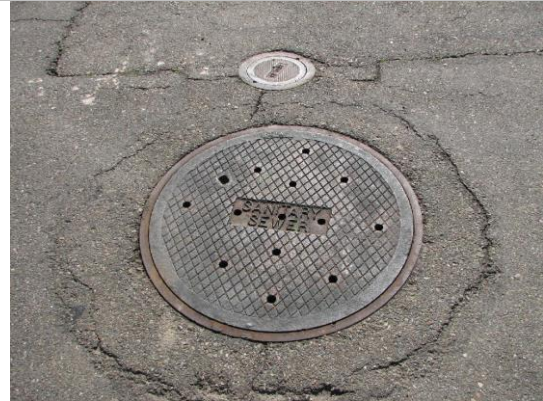
Photo 3 of 3 : UCIP_FA_2015_2339.jpg

LM Start	1.31	Rating **	M	Issue No.	10 (cont)
LM End	1.31	Issue Type +	En	Location *	WS
Category	Supplemental			GPS Latitude/Longitude	
				Start	End
Item	DWR UCIP Field Study			37.915928 °	37.915928 °
				-121.312471 °	-121.312471 °
DWR ID					
Action/Comments					
Inspector Comments: FS_ID:40605					
DS_ID:159					
EP_NO: 14992					
FS_HLM: 1.33					
Repair Type: Non-Urgent					
Crossing Status: Indicator Found

Manhole for sanitary sewer visible on landward side.

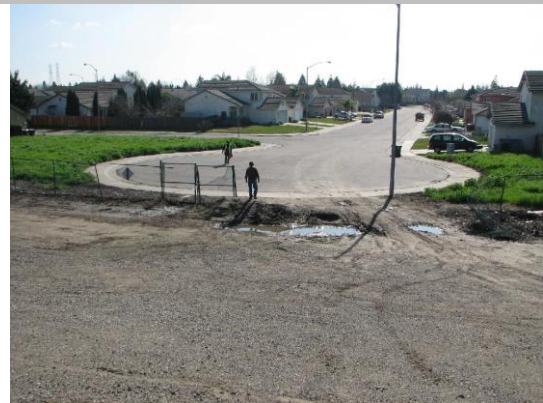
Photo 1 of 3 : UCIP_FA_2015_0701.jpg

LM Start	1.31	Rating **	M	Issue No.	11
LM End	1.31	Issue Type +	En	Location *	WS
Category	Supplemental			GPS Latitude/Longitude	
				Start	End
Item	DWR UCIP Field Study			37.915928 °	37.915928 °
				-121.312471 °	-121.312471 °
DWR ID					
Action/Comments					
Inspector Comments: FS_ID:40604					
DS_ID:2					
EP_NO: 14992					
FS_HLM: 1.33					
Repair Type: Non-Urgent					
Crossing Status: Indicator Found					
UCIP Comments: Need to contact owner to determine status of crossing. Also need date of last inspection.					
FIELD_STRUCT_DESC: 1 of 3. 30-inch diameter HDPE sewer force main (SFM). All pipes encased in concrete at approximately 32 feet below levee crown. (Permit No. 14992-1989)					
FS Date: 02/03/2010

View of landward side.

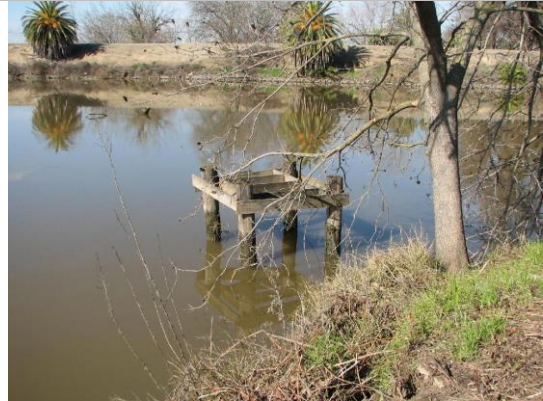
Photo 3 of 3 : UCIP_FA_2015_2341.jpg

LM Start	0.14	Rating **	M	Issue No.	569 (cont)
LM End	0.14	Issue Type +	En	Location *	LS
Category	Supplemental			GPS Latitude/Longitude	
				Start	End
Item	DWR UCIP Field Study			37.914335 °	37.914335 °
				-121.322387 °	-121.322387 °
DWR ID					
Action/Comments					
Inspector Comments: FS_ID:40628					
DS_ID:75					
EP_NO: 15093					
FS_HLM: 0.1426					
Repair Type: Non-Urgent					
Crossing Status: Found

View of waterward side--pillings inside channel.

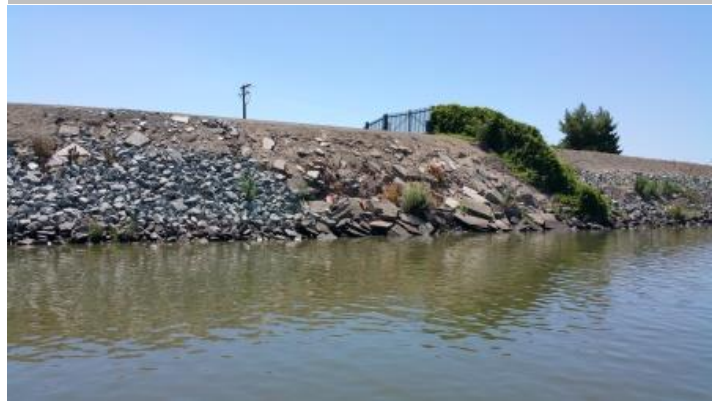
Photo 1 of 2 : SJR2015_RD0017U02RM44.32_1.jpg

LM Start	1.08	Rating **	U	Issue No.	2
LM End	1.08	Issue Type +	Ma	Location *	WS
Category	Supplemental			GPS Latitude/Longitude	
				Start	End
Item	DWR Erosion Survey			37.902530 °	37.902530 °
				-121.325690 °	-121.325690 °
DWR ID					
Action/Comments					
Inspector Comments: 06/24/2015: No significant change observed. 6/19/2014: No significant change observed. 08/13/2013: No significant change at this site. 08/07/2012: The erosion is nearly vertical, and has developed upward to halfway of the levee slope. The protecting concrete blocks have been washed away. Animal activities are visible. [2015 Site ID:RD0017U02RM44.32]

Front view of the erosion site. Note the concrete blocks and vegetation.

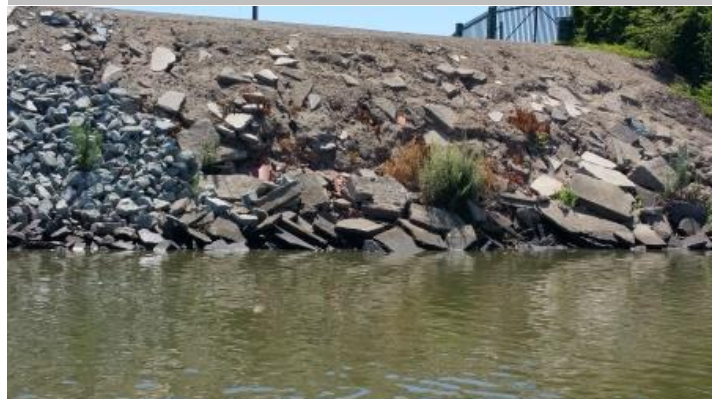
Photo 2 of 2 : SJR2015_RD0017U02RM44.32_3.jpg

Close view of the erosion.

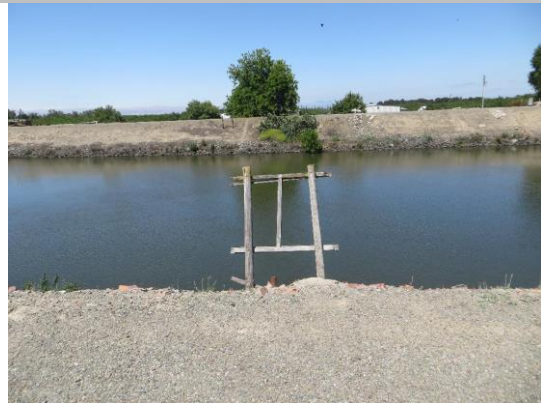
Photo 2 of 2 : UCIP_FA_2015_2566.jpg

Sign on WS slope.

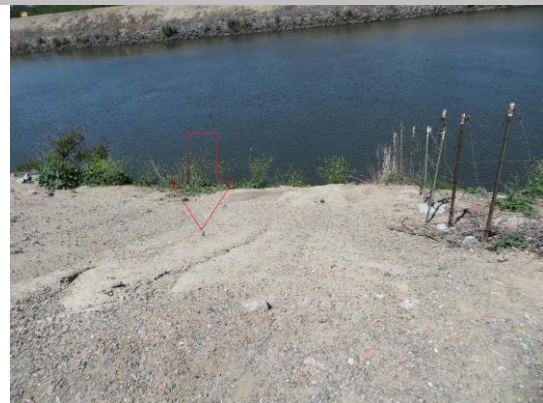
Photo 2 of 2 : UCIP_FA_2015_2570.jpg

View of WS slope with electrical conduit.

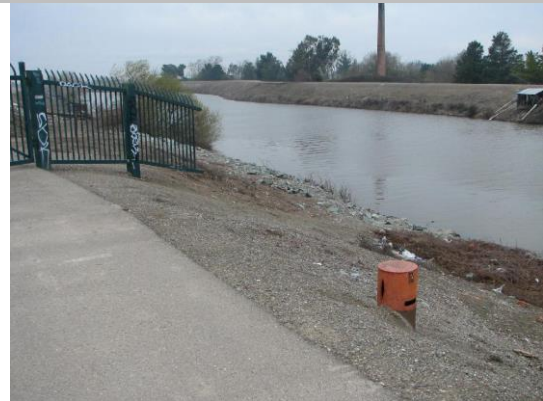
Photo 1 of 3 : UCIP_FA_2015_1865.jpg

LM Start	1.45	Rating **	M	Issue No.	574
LM End	1.45	Issue Type +	En	Location *	WS
Category	Supplemental			GPS Latitude/Longitude	
				Start	End
Item	DWR UCIP Field Study			37.897280 °	37.897280 °
				-121.326775 °	-121.326775 °
DWR ID					
Action/Comments					
Inspector Comments: FS_ID:40639					
DS_ID:11					
EP_NO: 15316					
FS_HLM: 1.4625					
Repair Type: Non-Urgent					
Crossing Status: Indicator Found

Siphon breaker located on waterward slope.

Inspector Comments: FS_ID:40639
 DS_ID:11
 EP_NO: 15316
 FS_HLM: 1.4625
 Repair Type: Non-Urgent
 Crossing Status: Indicator Found
 UCIP Comments: Need to contact owner to determine status--pipe was not found only siphon breaker housing unit.
 FIELD_STRUCT_DESC: 8 inch diameter discharge pipeline through levee. Invert of pipe is 3.8 feet below levee crown. Siphon breaker on the waterward shoulder. Pump is located inside ditch located approximately 75 feet landward of levee toe. (Permit No. 15316-1989)
 FS Date: 02/04/2010

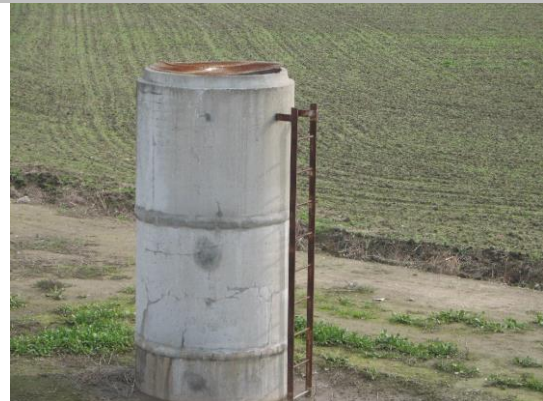
Photo 2 of 3 : UCIP_FA_2015_6511.jpg

Standpipe located on landward toe.

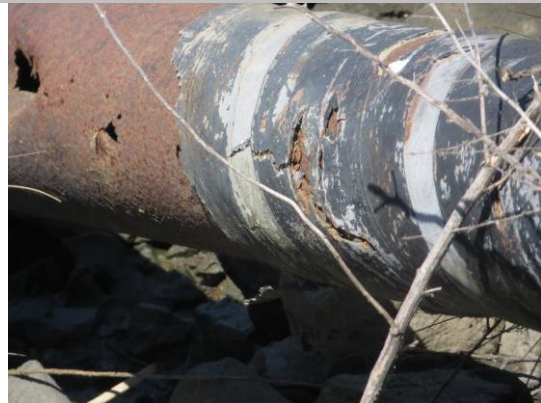
Photo 1 of 3 : UCIP_FA_2015_6003.jpg

(2015) Close-up of pipe wall damage.

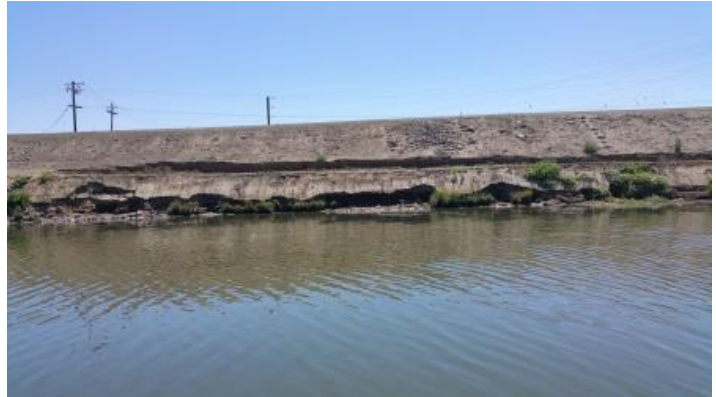
Photo 1 of 2 : SJR2015_RD0017U02RM45.95_1.JPG

Front view of the erosion site. Note the new cut at the middle levee slope.

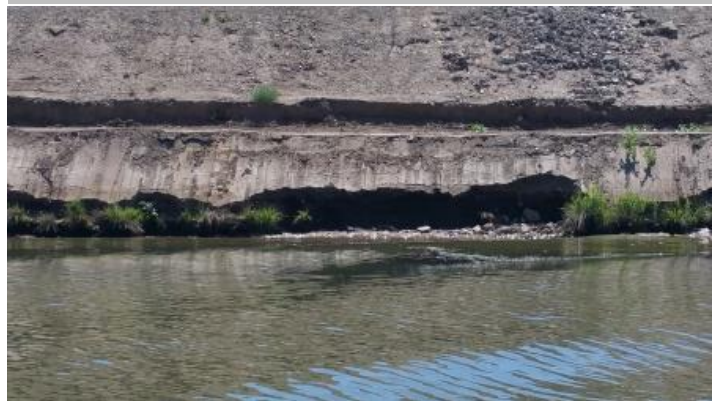
Photo 2 of 2 : SJR2015_RD0017U02RM45.95_4.JPG

Close view of the erosion.

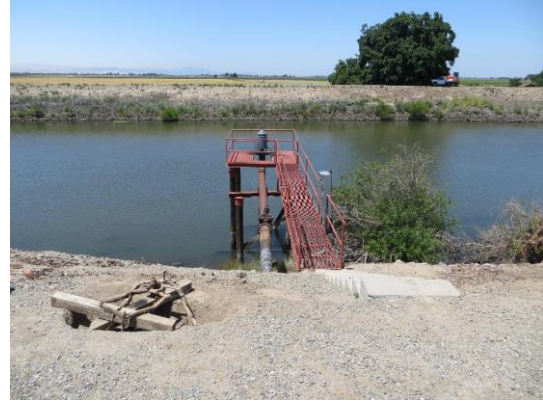
Photo 2 of 3 : UCIP_FA_2015_6007.jpg

(2015) View of waterward side--pit filled with wood debris will need to be filled and cleared.

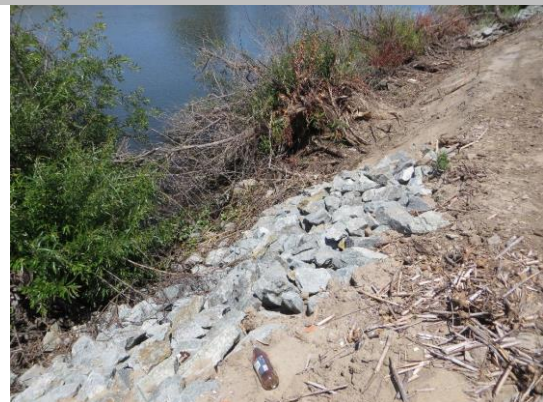
Photo 3 of 3 : UCIP_FA_2015_6008.jpg

(2015) Waterward slope armored with rip rap.

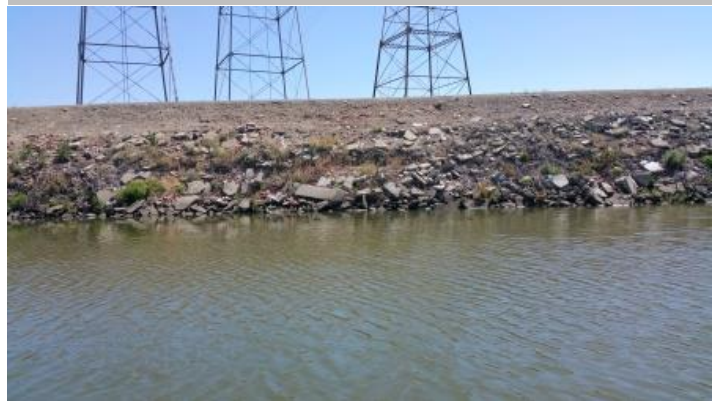
Photo 1 of 2 : SJR2015_RD0017U02RM46.10_1.JPG

Front view of the erosion.

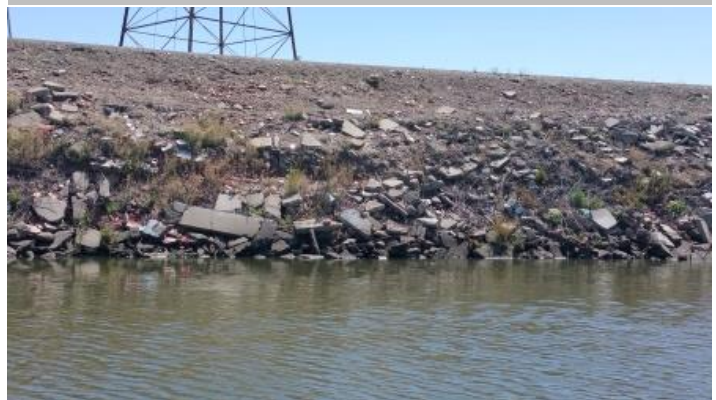
Photo 2 of 2 : SJR2015_RD0017U02RM46.10_3.JPG

Close view of the erosion. The slope protection is poor.

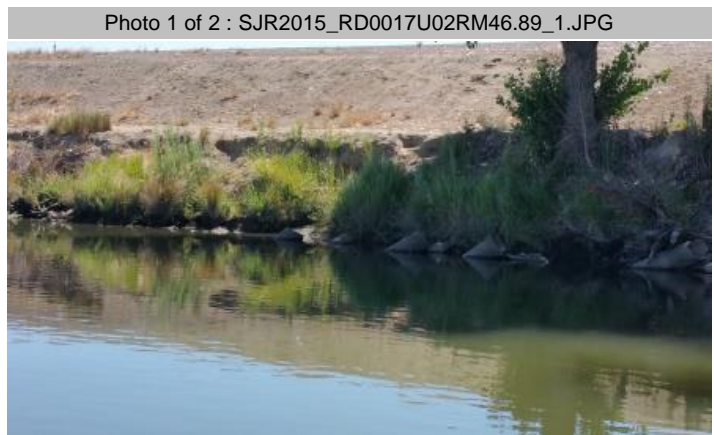
LM Start	3.63	Rating **	M	Issue No.	10
LM End	3.63	Issue Type +	Ma	Location *	WS
Category	Supplemental			GPS Latitude/Longitude	
				Start	End
Item	DWR Erosion Survey			37.868500 °	37.868500 °
				-121.327670 °	-121.327670 °
DWR ID					
Action/Comments					
Inspector Comments: 06/24/2015: No significant change observed. 06/19/2014: The erosion is near a large tree and probably has been caused by the irrigation pipe on the site. [2015 Site ID:RD0017U02RM46.89]

Front view of the erosion. Note the tree and the irrigation pipe.

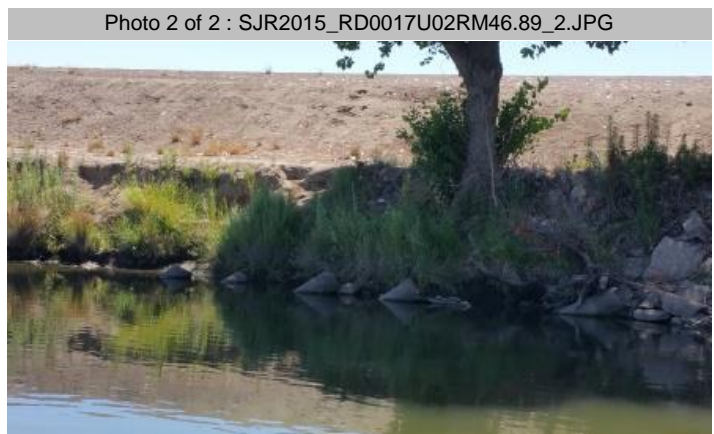
Close view of the erosion.

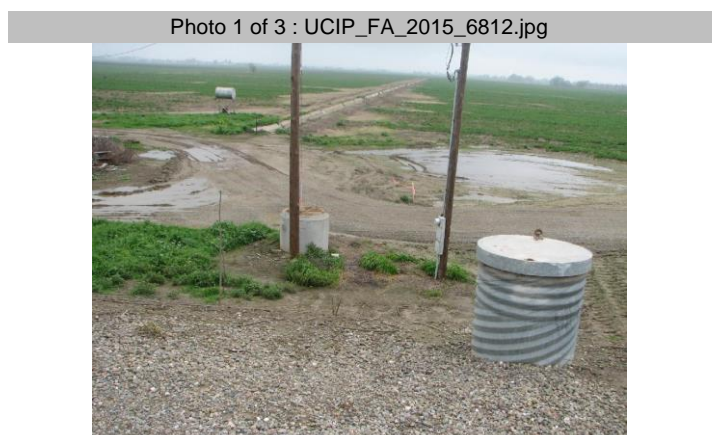
LM Start	3.73	Rating **	M	Issue No.	587
LM End	3.73	Issue Type +	En	Location *	WS
Category	Supplemental			GPS Latitude/Longitude	
				Start	End
Item	DWR UCIP Field Study			37.867247 °	37.867247 °
				-121.326724 °	-121.326724 °
DWR ID					
Action/Comments					
Inspector Comments: FS_ID:40660					
DS_ID:27					
EP_NO: 15110					
FS_HLM: 3.7789					
Repair Type: Non-Urgent					
Crossing Status: Found

Siphon breaker, standpipe, and powerline located on landward side.

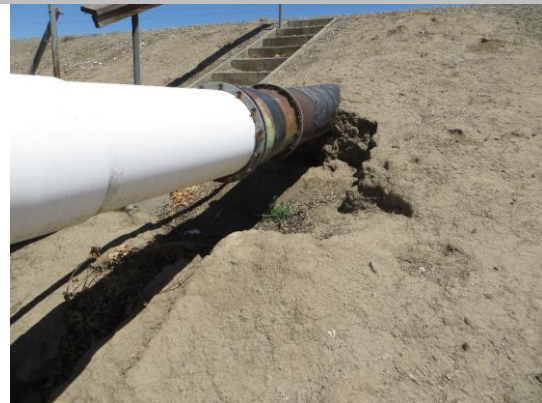
Photo 1 of 3 : UCIP_FA_2015_6033.jpg

(2015) View of waterward side--erosion at pipe daylight.

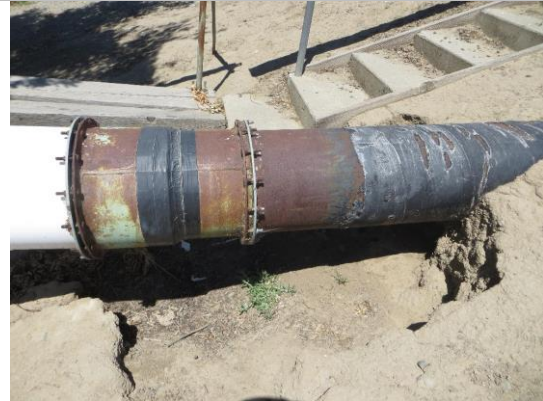
Photo 2 of 3 : UCIP_FA_2015_6034.jpg

(2015) Erosion visible on waterward side.

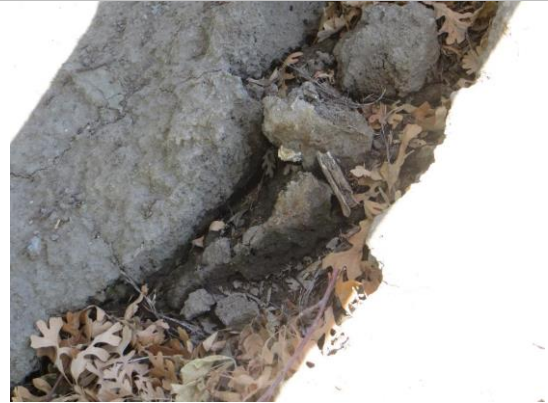
Photo 3 of 3 : UCIP_FA_2015_6035.jpg

(2015) Wet ground along pipe alignment on waterward side.

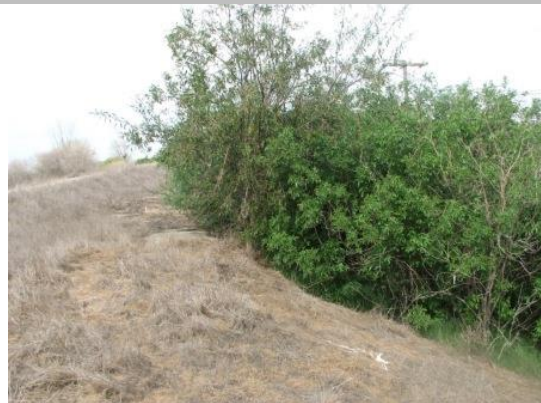
Photo 1 of 1 : FA_2015_RD0017_304_25_20150914_00007.jpg

Elderberry blocking view of landside slope and toe.

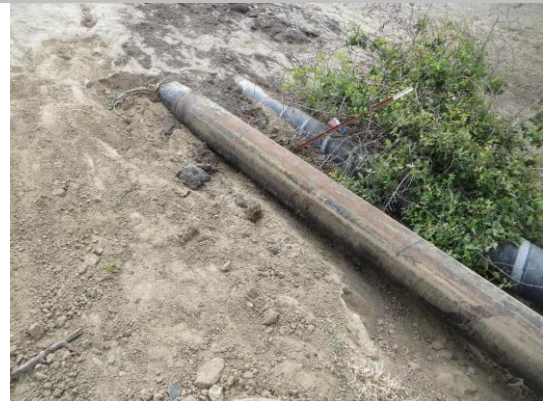
Photo 1 of 3 : UCIP_FA_2015_6014.jpg

(2015) View of waterward side--only 1 pipe section was replaced (1 of 2 and not 2 of 2)

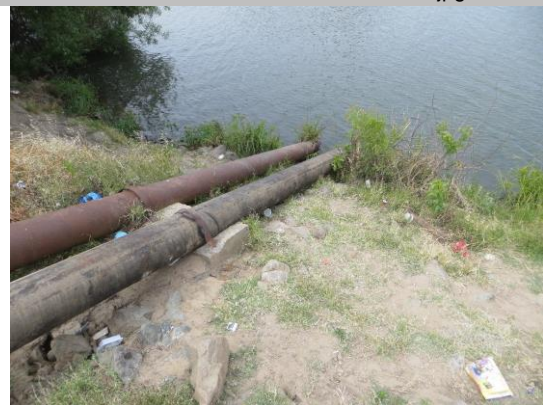
Photo 2 of 3 : UCIP_FA_2015_6015.jpg

(2015) View of second pipe not replaced.

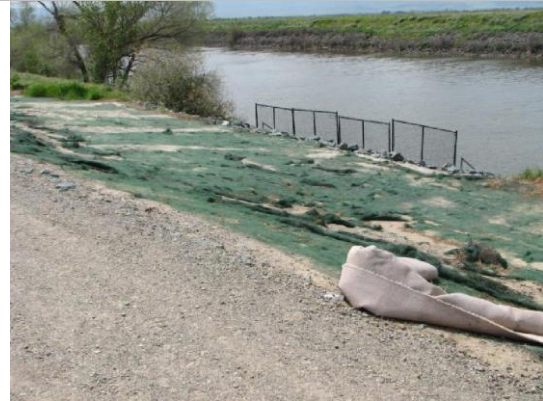
Photo 3 of 3 : UCIP_FA_2015_2273.jpg

View of waterward side geotech fabric damage along slope.

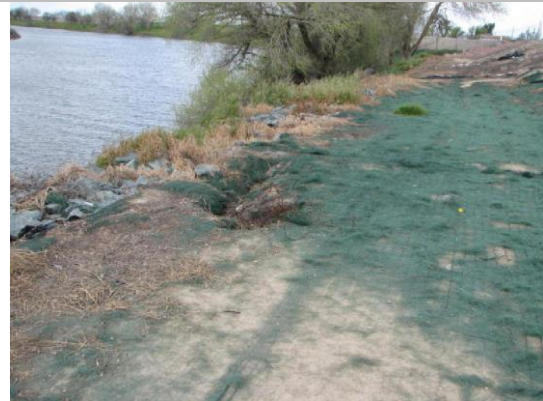
Photo 1 of 3 : UCIP_FA_2015_1839.jpg

Surface erosion visible on waterward berm edge.

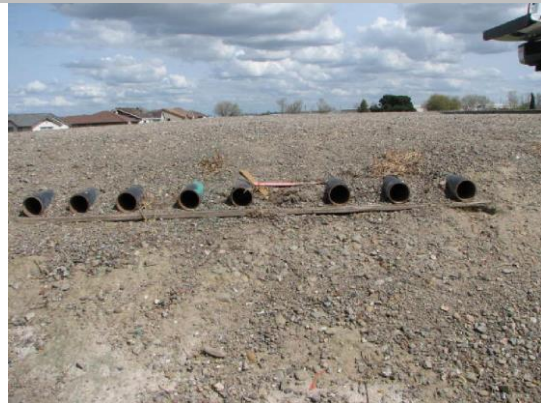
Photo 3 of 3 : UCIP_FA_2015_6471.jpg

8-4 inch steel coated schedule 40 pipes with about 6 inch of cover.

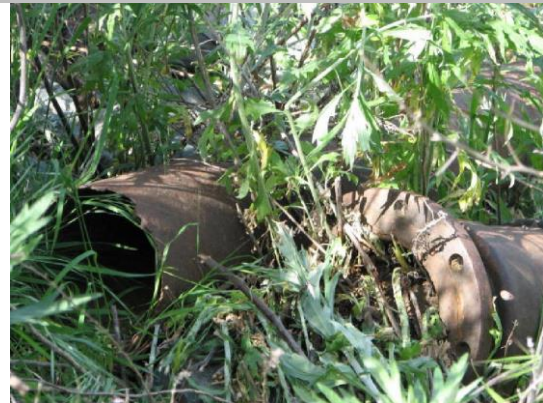
Photo 2 of 3 : UCIP_FA_2015_5516.jpg

Non-functional crossing pipe disconnected.

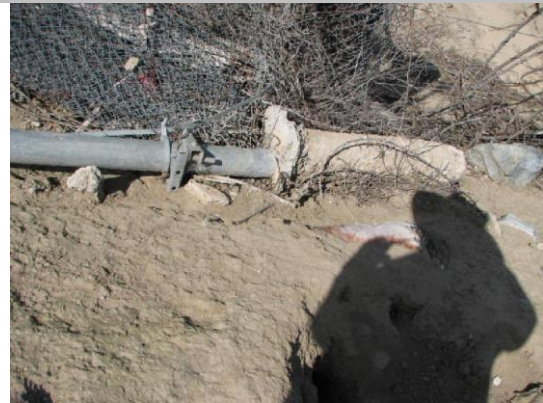
Photo 1 of 3 : UCIP_FA_2015_5523.jpg

Pipe section exposed on landward side.

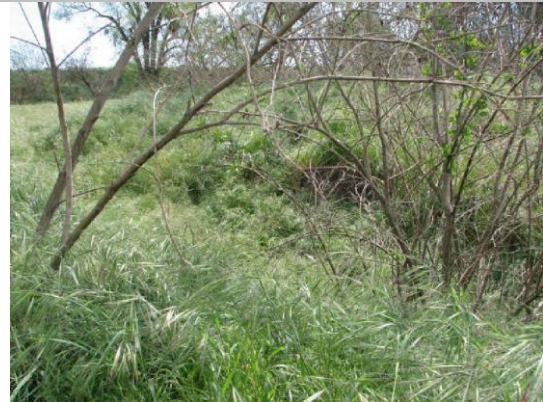
Photo 1 of 3 : UCIP_FA_2015_6280.jpg

Scour hole located immediately upstream from crossing.
